Town of York POC:

April 5, 2023

Waterfront Facilities Inspection Brief

**Appledore Marine
Engineering, LLC**

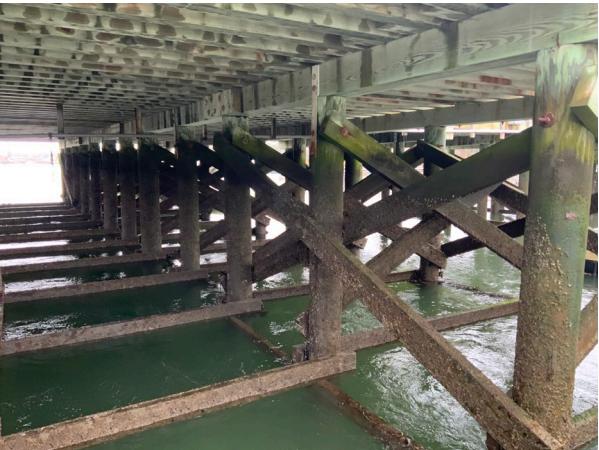
Piles, Bracing, and Pile Caps

Typical condition of piles, bracing, and pile caps with no significant defects under the pier.

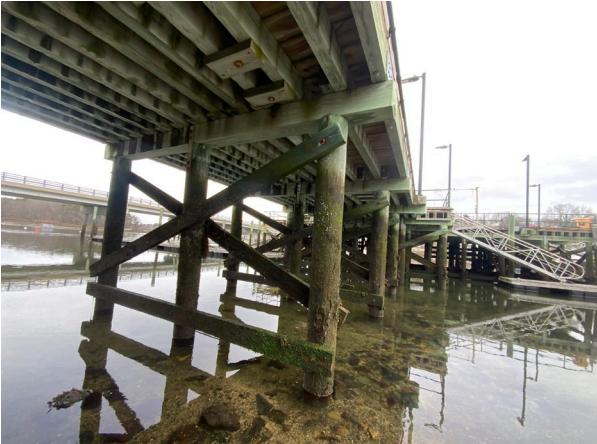
Piles, Bracing, and Pile Caps

Typical condition of piles, bracing, and pile caps with no significant defects under the access trestle.

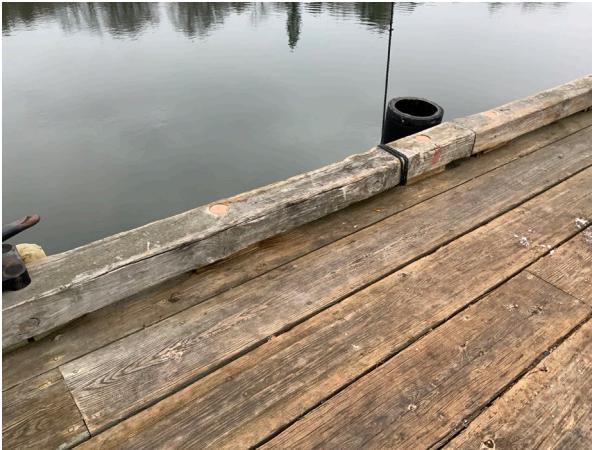
Exterior Curb

Outboard timber curb with minor abrasion damage.

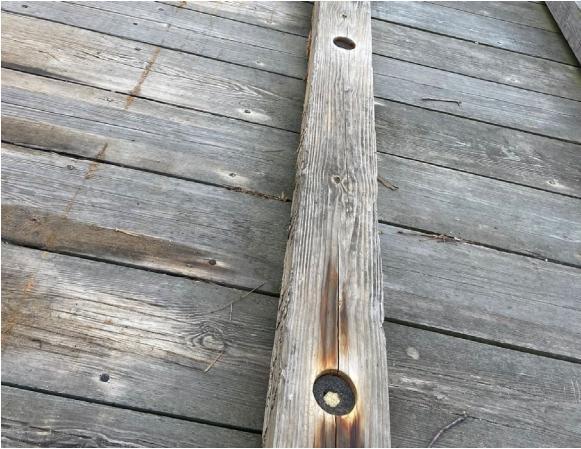
Interior Curb

Interior timber curb with missing nut pocket sealant.

Priority Level	Element	Recommendations
0-3 years	Curb	Install nut pocket sealant on the interior curb.
	Mooring Hardware	Clean and recoat cleats.
	Utilities	Replace conduits with heavy corrosion.
		Replace hangers that are missing or have heavy corrosion.
		Install new gaskets at all junction boxes.
		Install missing junction box cover.
		Install missing junction box hardware.
Miscellaneous		Install missing bolt on guardrail.
3+ years	Deck	Replace approximately 5% of the deck planks.

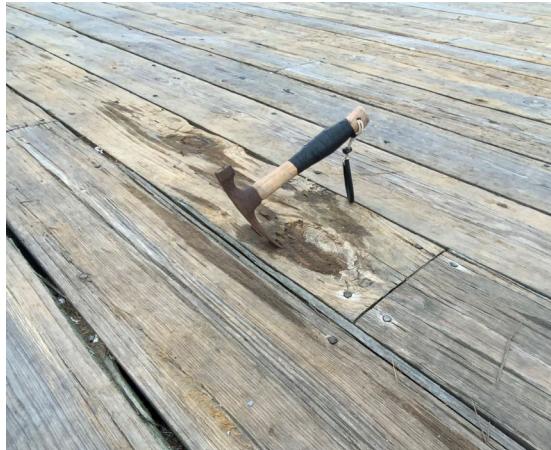
Deck

Typical condition of timber deck with localized areas of moderate fungal decay.

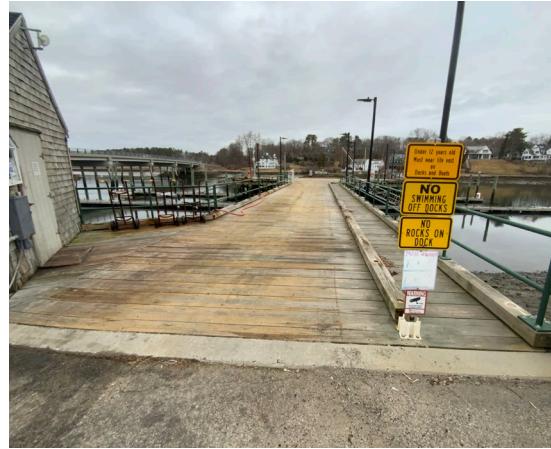
Access Trestle Deck

Typical condition of access trestle's timber deck with moderate abrasion and fungal decay.

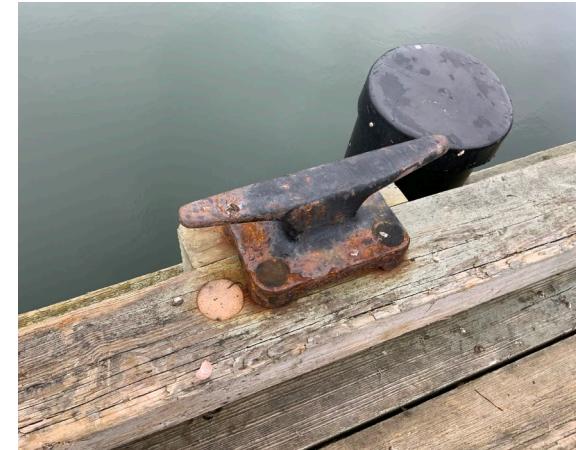
Mooring Hardware

Mooring cleat with moderate corrosion.

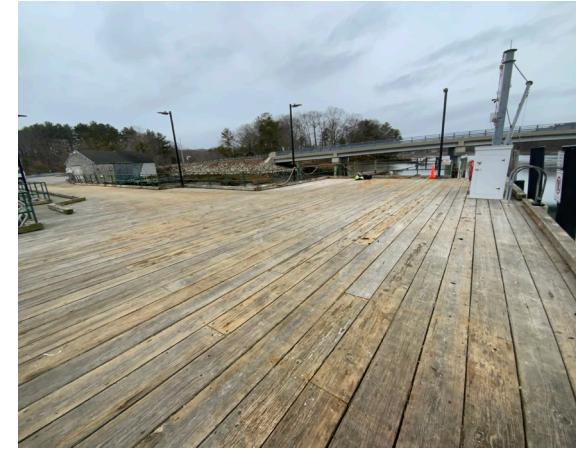
Pier Deck

Typical condition of the pier's timber deck with moderate abrasion.

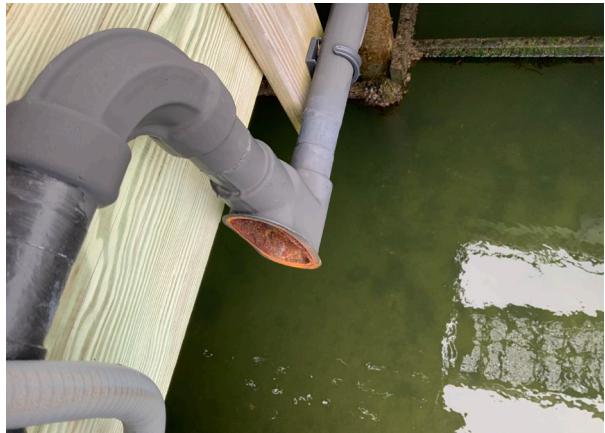
Junction Box

Missing junction box cover.

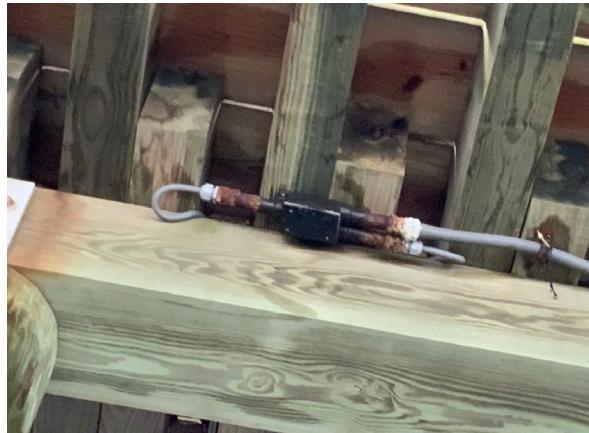
Electrical Conduit

Electrical conduit with moderate corrosion.

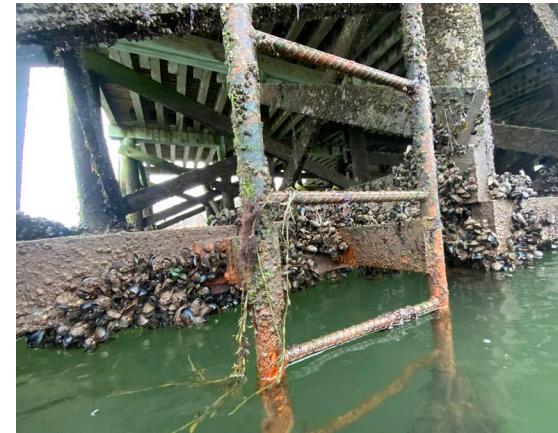
Ladder

Typical condition of ladder with minor corrosion within the low water and tidal zones.

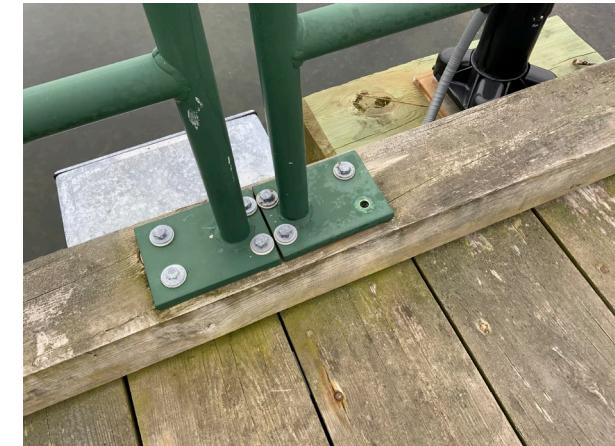
Guardrail with a missing bolt.

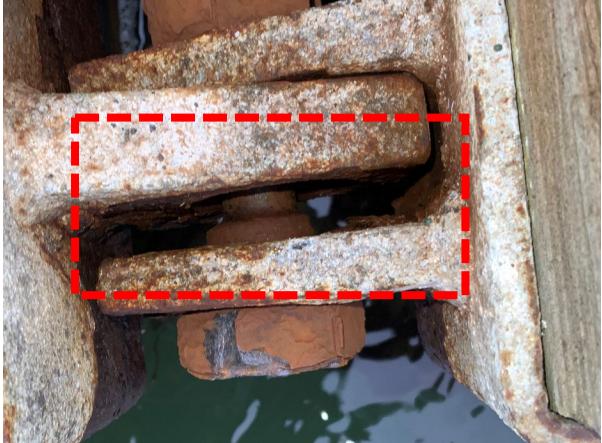
Pin Connections

Severe section loss of pin on northwest floating dock.

Priority Level	Element	Recommendations
0-3 years	Float Modules	Replace pin connection with severe section loss.
		Replace the screw at the southeast floating dock pin connection with a cotter pin.
	Guide Pile Assemblies	Relocate guide pile assemblies that are causing abrasion damage to the guide piles.
	Gangways	Replace linchpins with moderate corrosion.
		Replace heavily corroded gangway wheels.
		Replace overstressed deck grates.
3+ years	Mooring Hardware	Tighten cleats.
	Floating Dock System	The floating dock system is near the end of its service life and therefore it is recommended that the entire system be replaced.
	Abrasion Plates	Replace timber abrasion plates with Ultra High Molecular Weight Polyethylene (UHMW) plates.

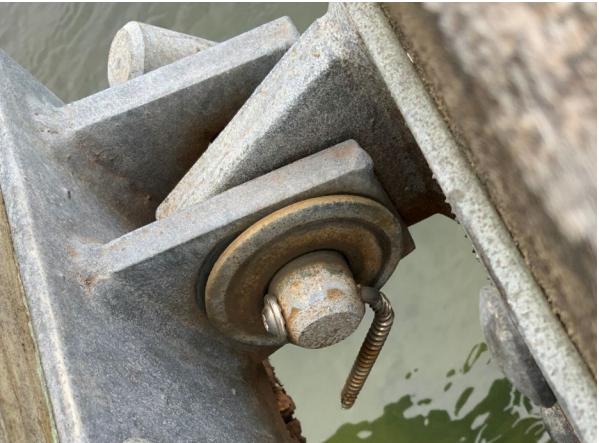
Pin Connections

Screw in pin connection in lieu of cotter pin.

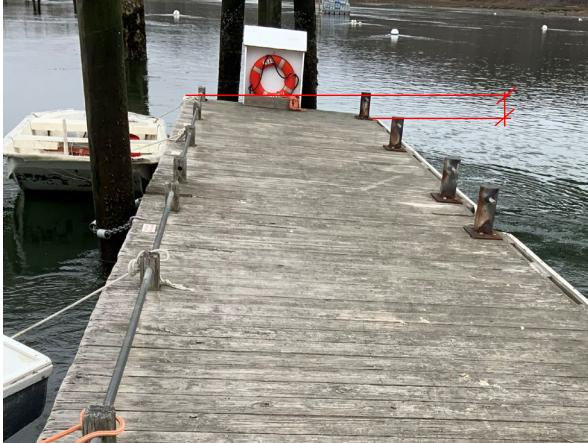
Deck

Typical condition of timber decking with moderate weathering. Note the listing of the float.

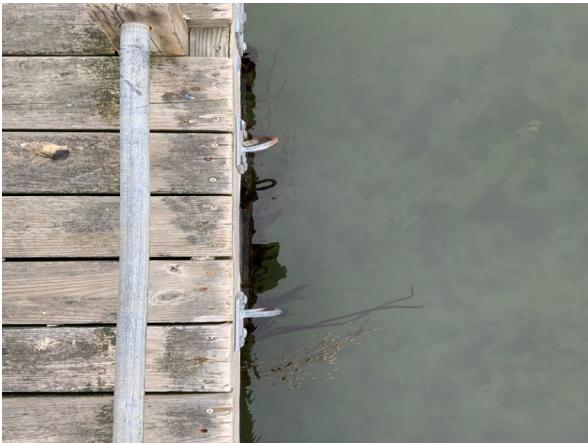
Guide Piles

Guide pile missing at end of the southeast floating dock.

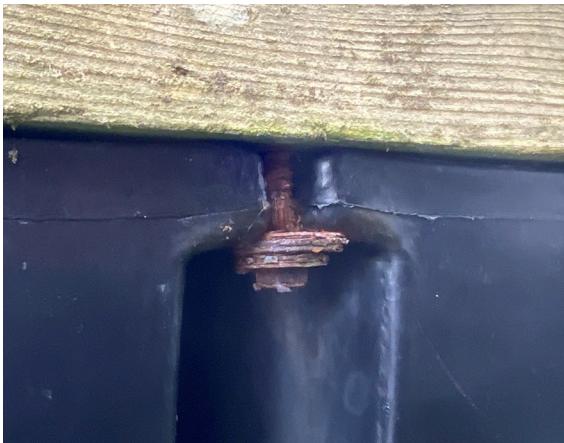
Dock Connection Hardware

Typical severe corrosion of the connection hardware of plastic float and float module.

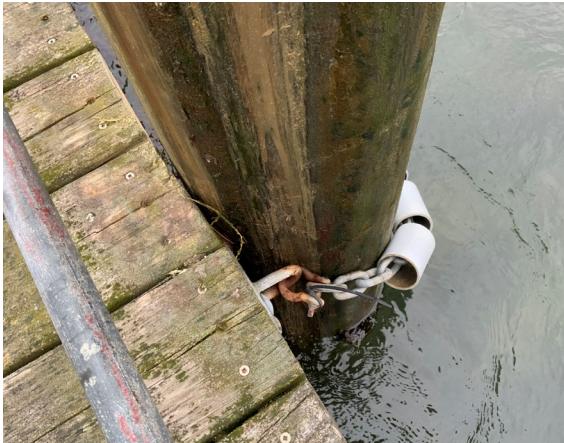
Guide Pile Assembly

Abrasion damage of guide pile from misaligned guide pile assembly.

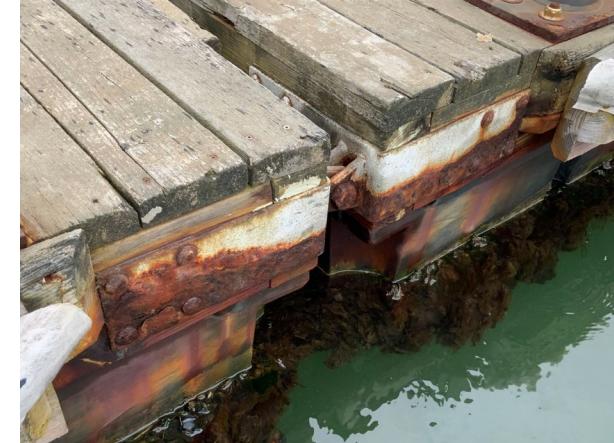
Connection Plates

Moderate corrosion of connection plates.

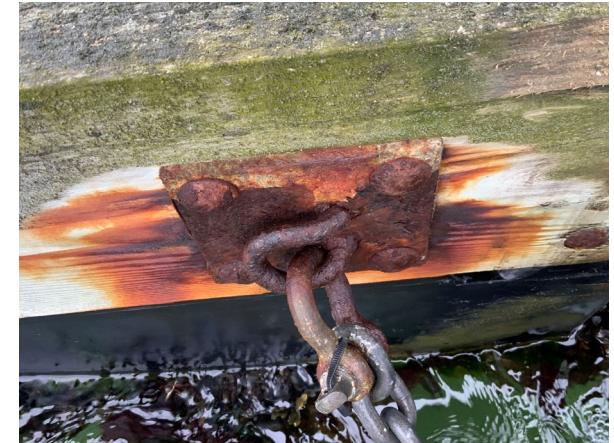
Guide Pile Assembly

Broken guide pile assembly connection on northeast floating dock.

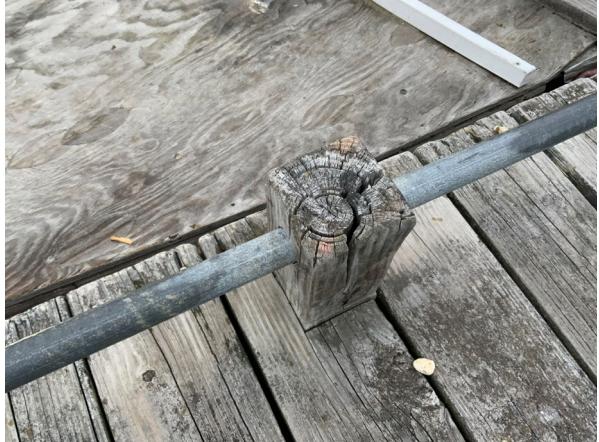
Curbs

Typical timber curb support with moderate splitting and fungal decay.

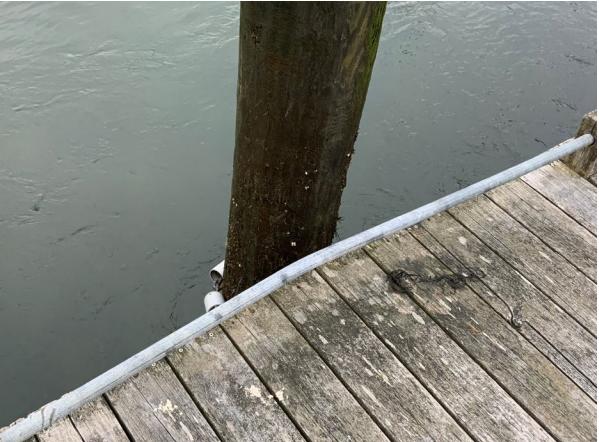
Curbs

Impact damage to steel curb.

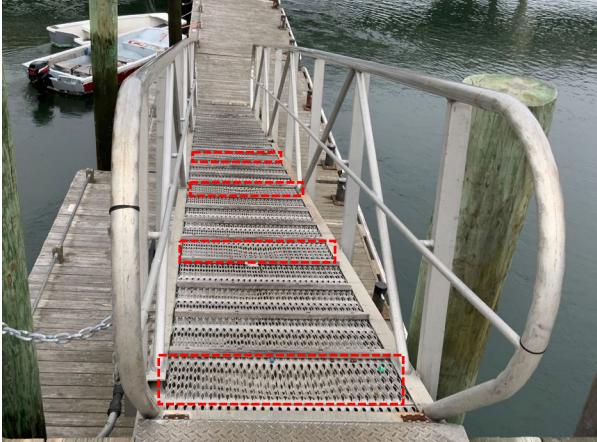
Gangways

Western gangway with overstressed deck grates.

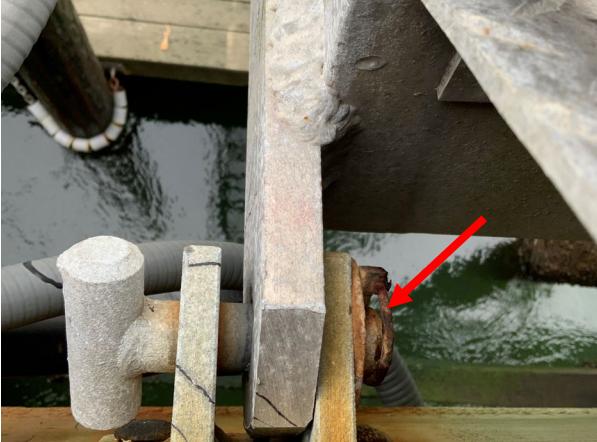
Gangways

Moderate corrosion of gangway linchpin.

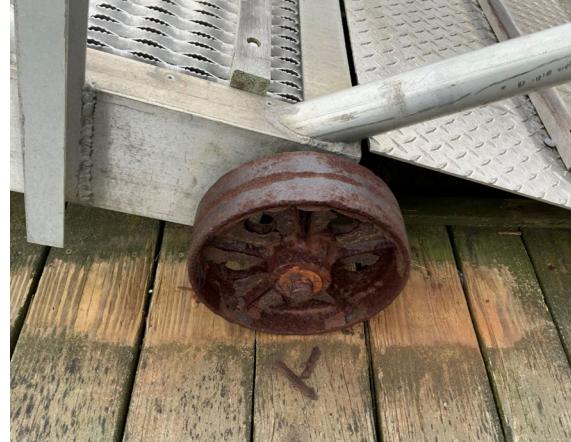
Gangways

Moderate corrosion of the western gangway wheel.

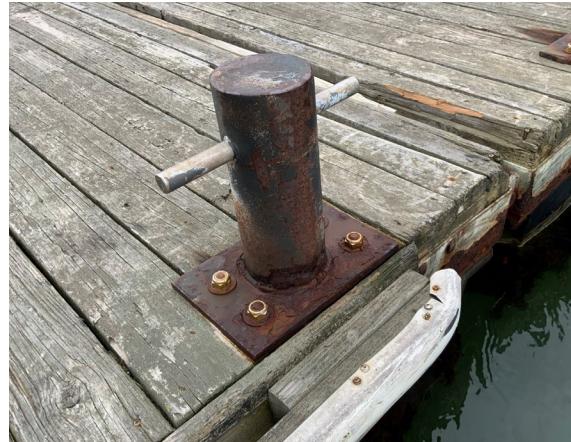
Bollards

Typical moderate corrosion of bollard.

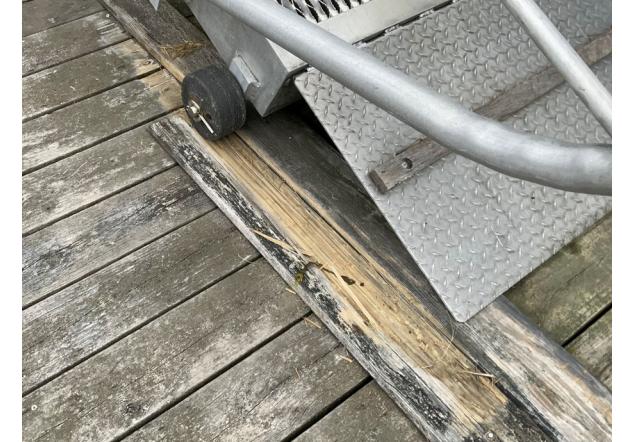
Abrasion Plates

Severe abrasion to the timber abrasion plate.

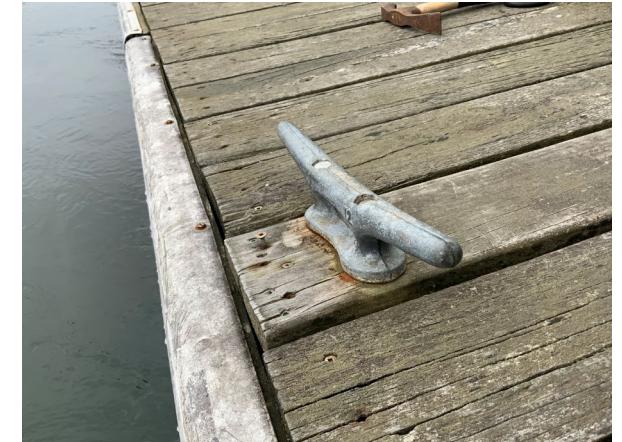
Cleats

Typical loose cleat.

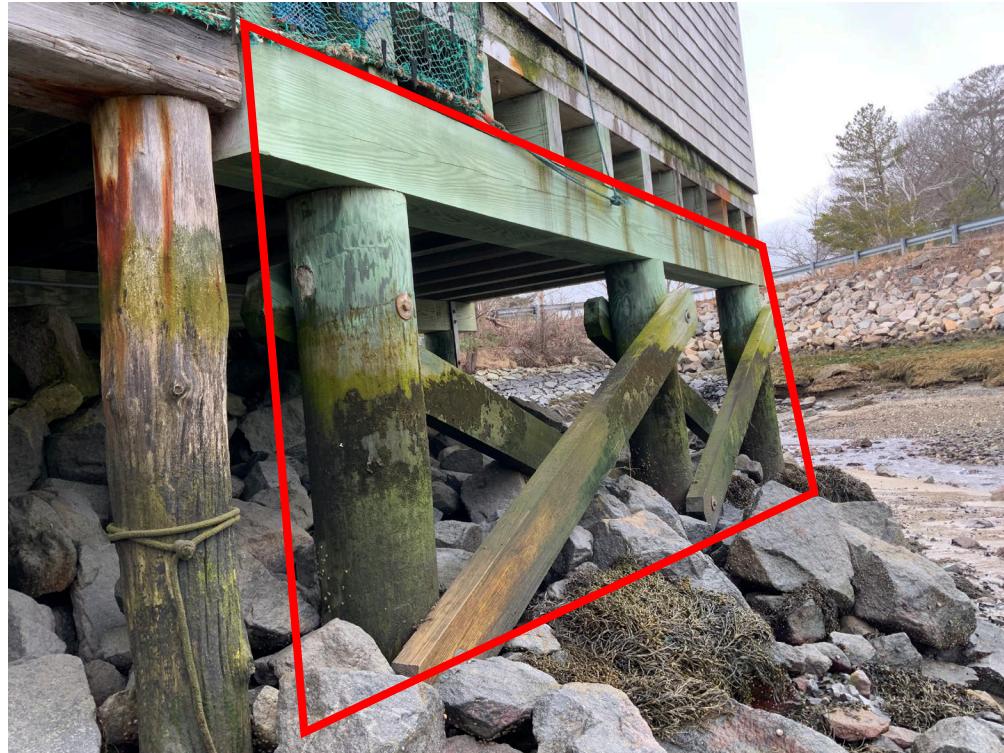
Piles, Bracing, and Pile Caps

Typical condition of piles, bracing, and pile caps.

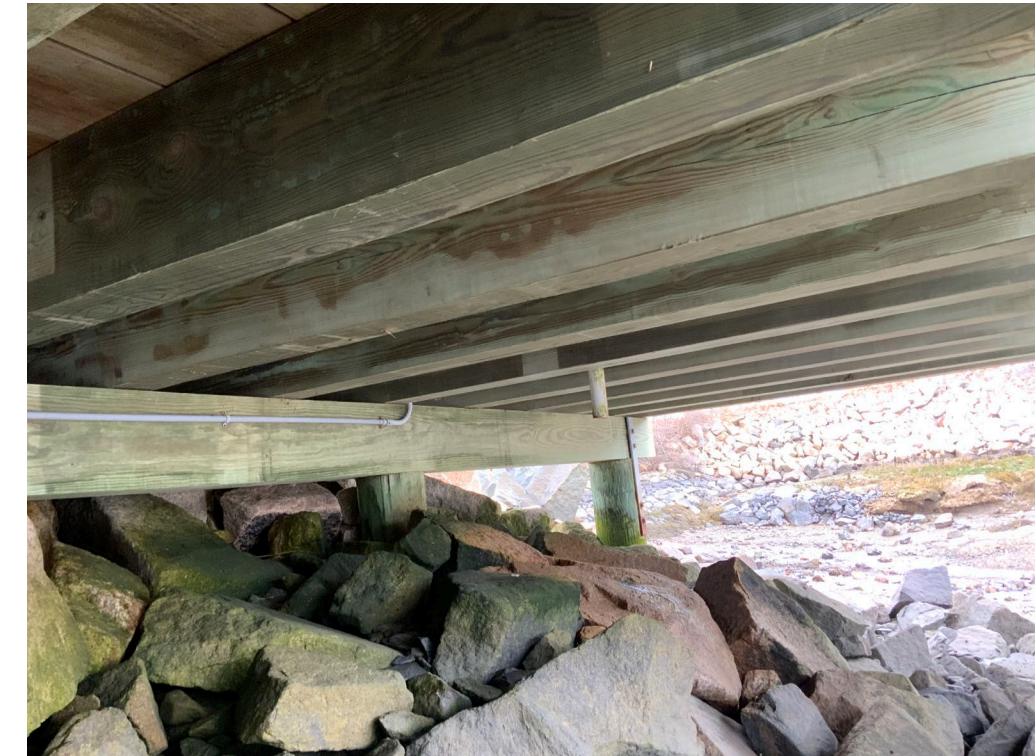
Stringers

Typical condition of timber stringers.

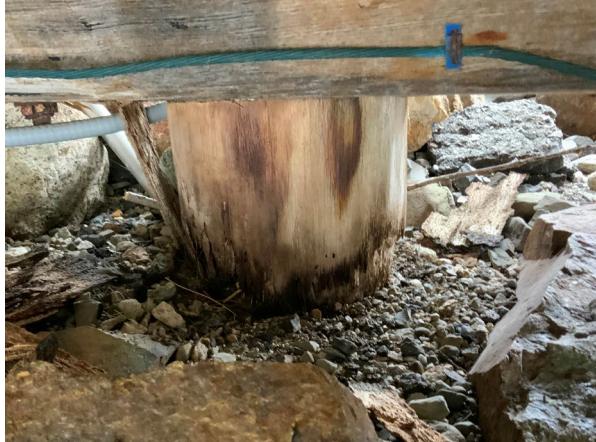
Piles

Fungal decay of inshore timber pile.

Priority Level	Element	Recommendations
0-3 years	General	Due to the deterioration of the piles and building the facility is near the end of its service life and therefore it is recommended that the structure be replaced entirely.

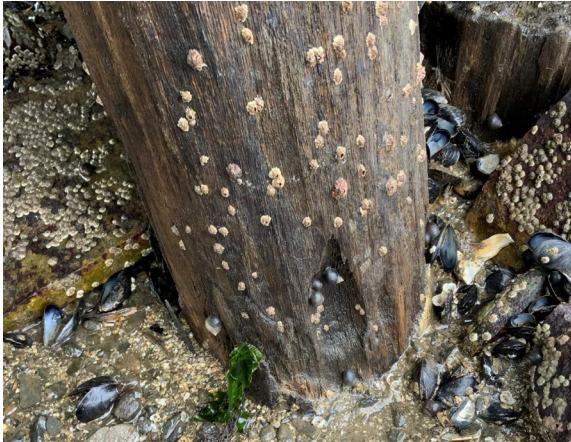
Piles

Pile with moderate section loss due to marine borer.

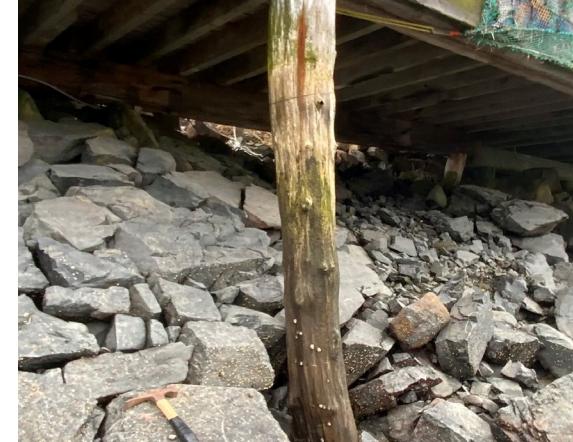
Piles

Offshore pile with major section loss.

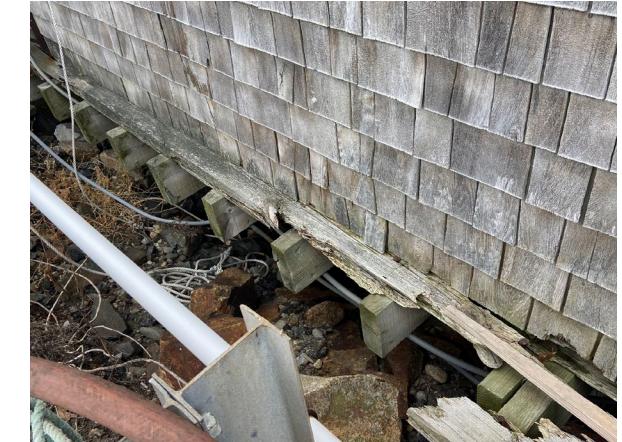
Timber Deck

Severe fungal decay of exterior portions of the timber deck.

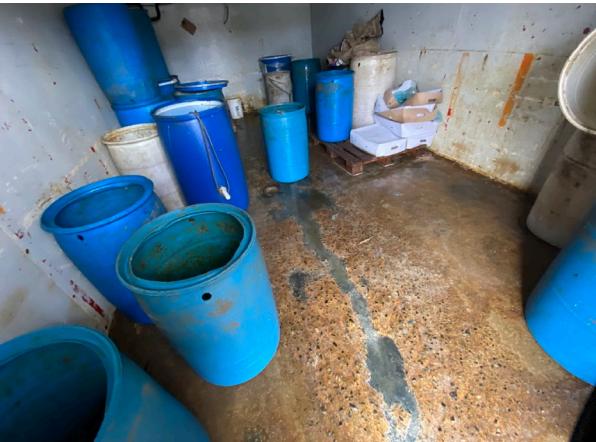
Concrete Overlay

Concrete overlay with chipped-out portions to promote drainage.

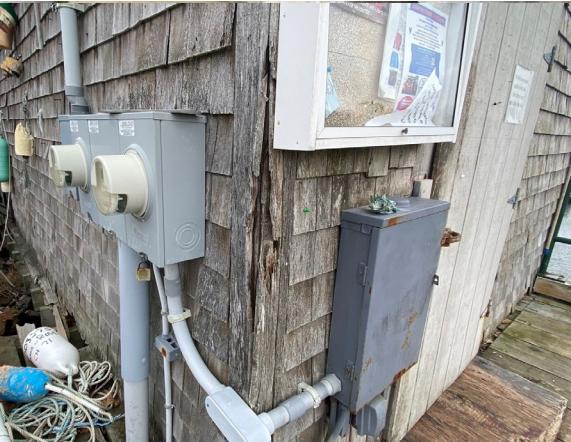
Building

Timber building with severe fungal decay.

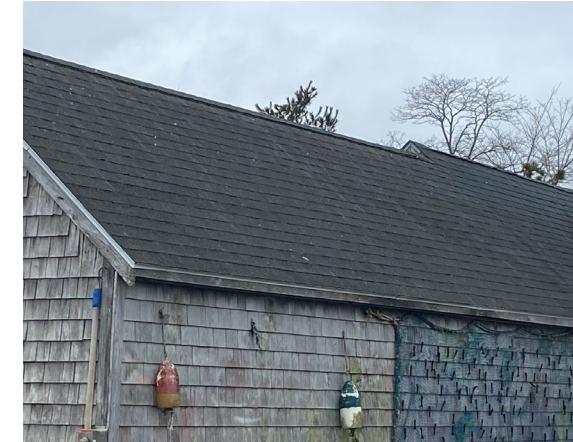
Building roof with moss and fungal growth.

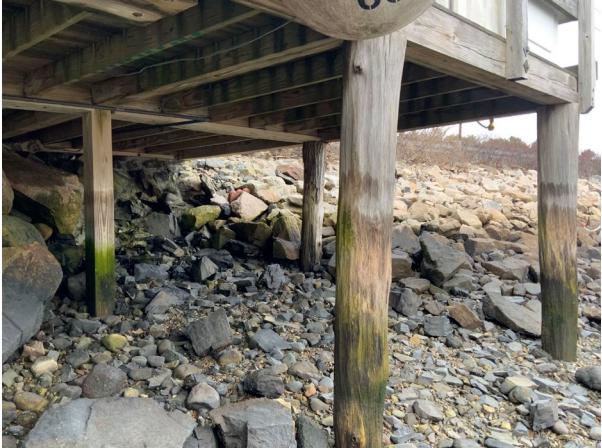
Typical condition of timber piles supporting the harbor master building with major section loss.

Priority Level	Element	Recommendations
Immediate	Guardrail	Install guardrail along the eastern side of the pier.
0-3 years	Utilities	Install missing utility hangers.
3+ years	Piles	Replace piles.

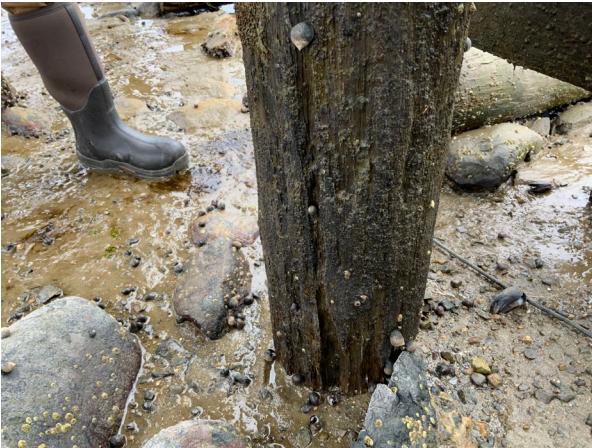
Piles

Timber pile with severe section loss due to marine borer deterioration.

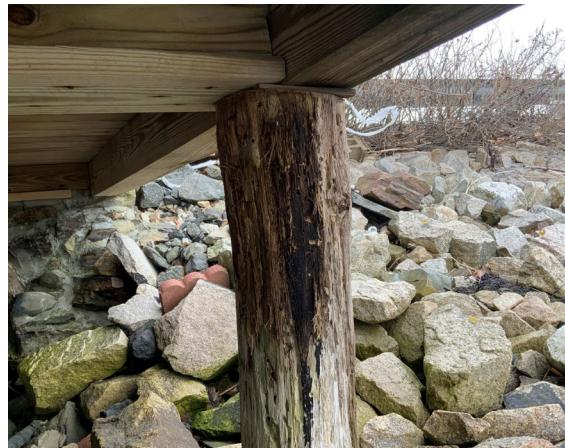
Piles

Typical pile head with fungal decay.

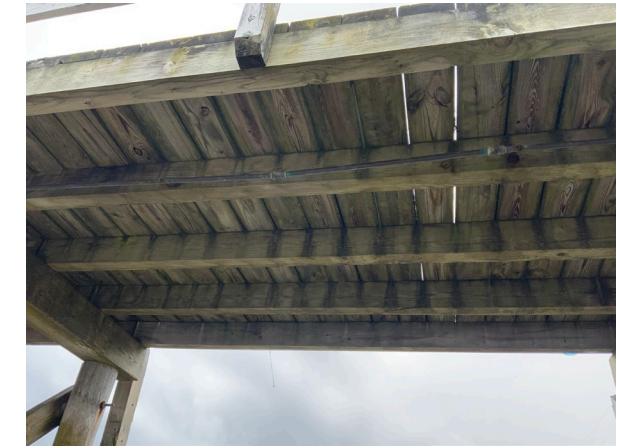
Stringers

Typical condition of timber stringers.

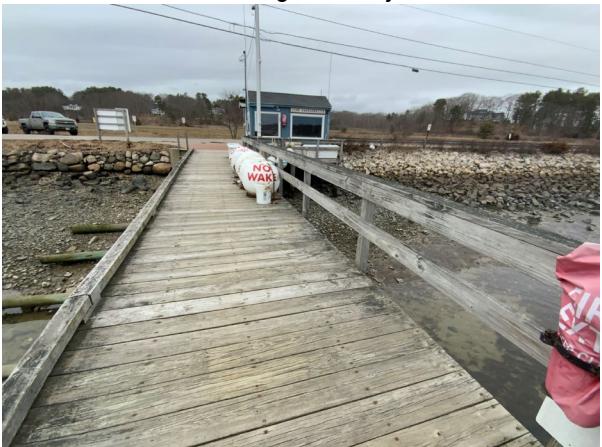
Deck

Typical condition of timber deck with minor weathering.

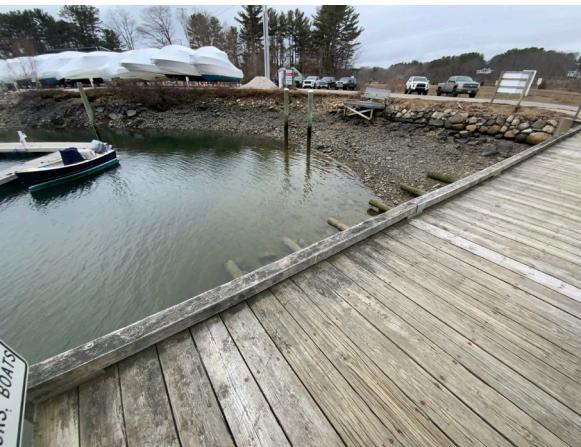
Guardrail

The eastern side of the pier with no fall protection.

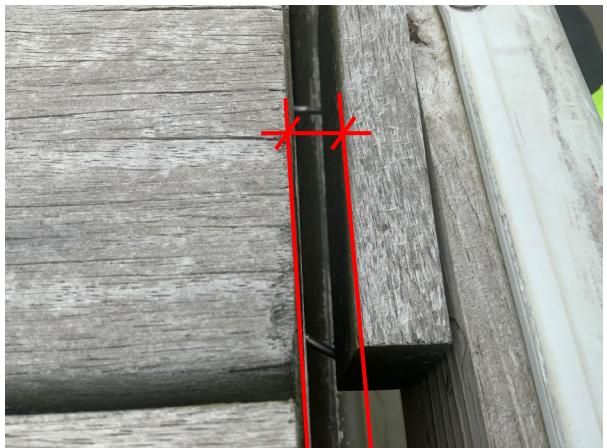
Fendering

Disconnected section of fender element on offshore face of floating dock.

Priority Level	Element	Recommendations
0-3 years	Fender System	Reconnect the loose fender element.

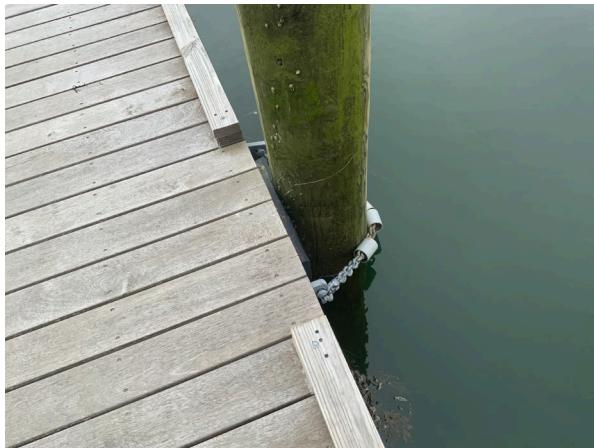
Guide Piles and Assemblies

Typical condition of the guide pile and guide pile assemblies.

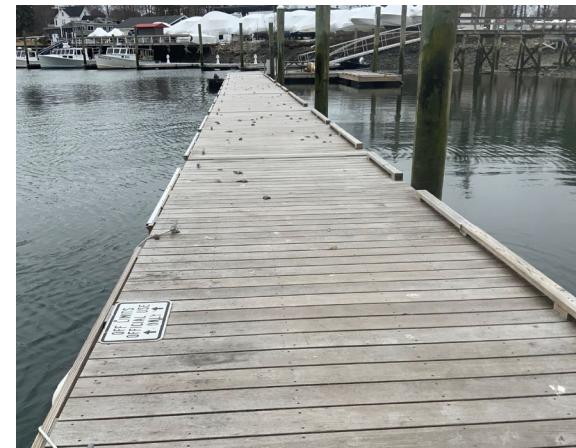
Deck

Typical condition of timber decking.

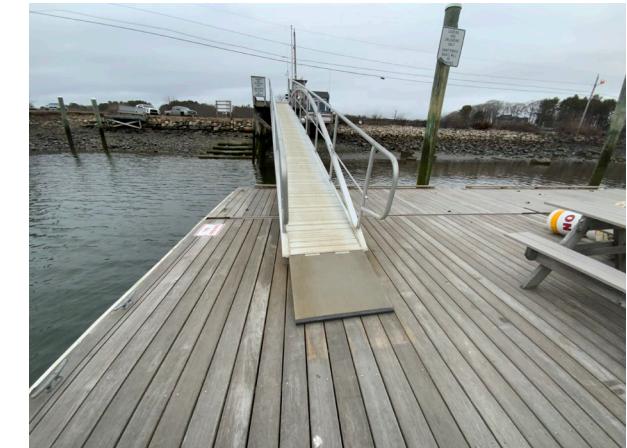
Gangway that provides access to the floating docks.

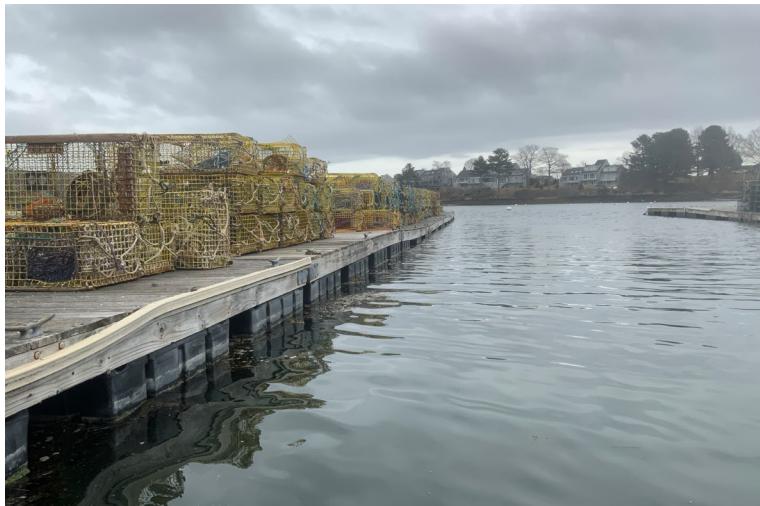
Floating Dock B with loss of floatation.

Priority Level	Element	Recommendations
0-3 years	Floating Dock B	Tighten loose pin connection.
		Replace one linchpin with moderate corrosion.
		Tighten cleats.
3+ years	Floating Dock C	Tighten cleats.
	Floating Dock B	Due to the loss of floatation of the floating dock, it is recommended that it be replaced.
3+ years	Floating Dock C	Due to the loss of floatation of the floating dock, it is recommended that it be replaced.

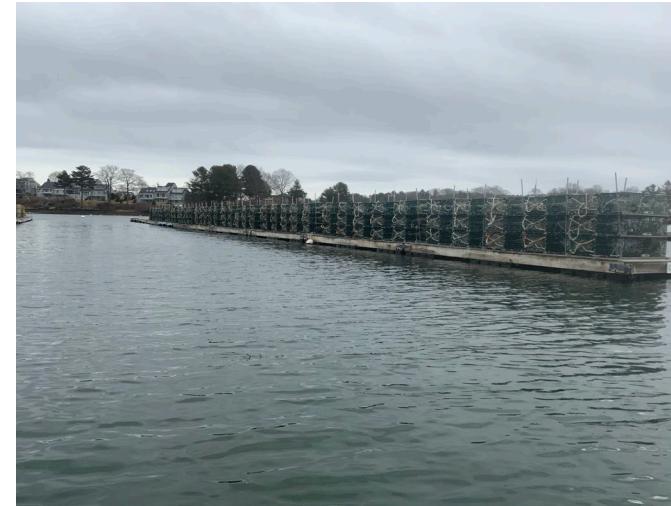
Floating Dock C with loss of floatation.

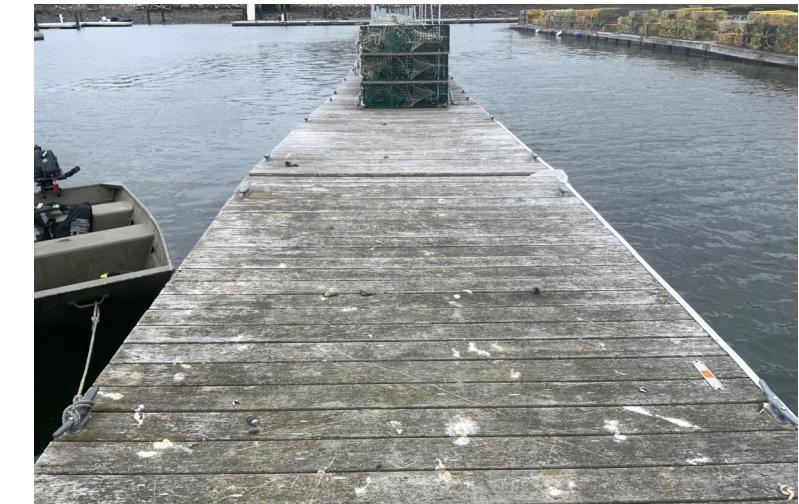
Deck

Typical condition of timber deck with minor weathering and fungal decay.
