Town of York POC:

April 5, 2023

Waterfront Facilities Inspection Brief

**Appledore Marine
Engineering, LLC**

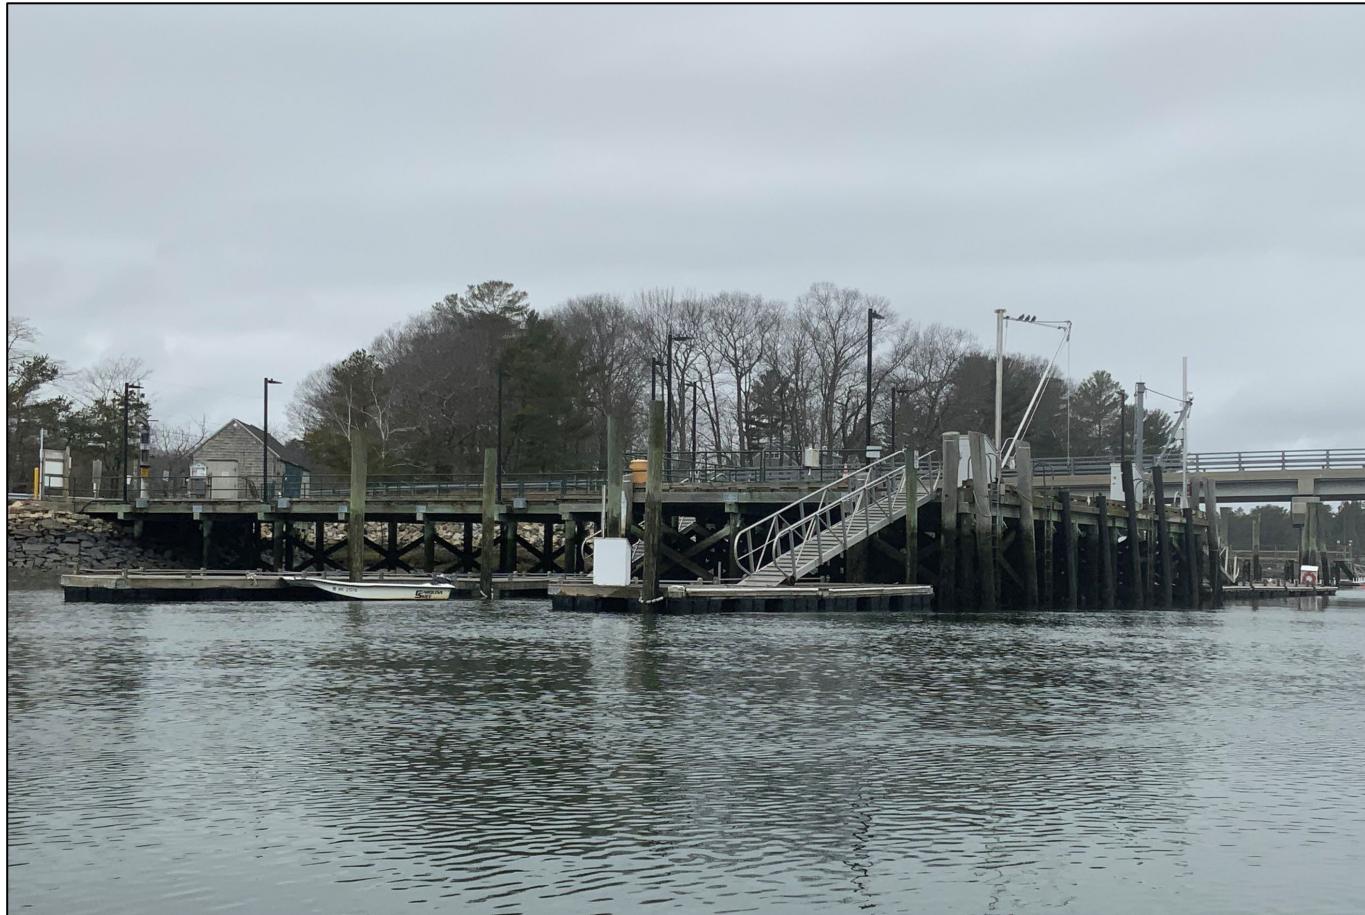
Overall Condition Assessment Rating	Next Recommended Inspection
Satisfactory	2027

Element	Observed Conditions
Piles	The timber piles supporting the pier have no significant defects.
Bracing	The diagonal, longitudinal, and transverse timber bracing elements have no significant defects.
Pile Caps	The pile caps have no significant defects.
Stringers	The timber stringers have no significant defects.
Deck	The timber deck generally has moderate abrasion and minor to moderate fungal decay.
Curb	The timber curbs have minor weathering and abrasion. The interior curb has isolated locations where the nut pocket sealant is missing. The curb connection hardware has minor to moderate corrosion.
Fender System	The fender system consists of timber chocks, wales, and composite piles. The chocks and wales have no significant defects, and the fender piles have minor abrasion.
Mooring Hardware	The mooring hardware consists of five cleats located along the outboard section of the pier. The fittings and connection hardware have minor to moderate corrosion.

Utilities	The electrical conduits have isolated areas of corrosion and missing or heavily corroded hangers. One junction box is missing a cover and the remaining junction box covers are typically missing hardware.
Miscellaneous	The ladders have minor corrosion within the tidal and low water zones and the guardrail is missing one bolt.

Priority Level	Element	Recommendations
0-3 years	Curb	Install nut pocket sealant on the interior curb.
	Mooring Hardware	Clean and recoat cleats.
	Utilities	Replace conduits with heavy corrosion.
		Replace hangers that are missing or have heavy corrosion.
		Install new gaskets at all junction boxes.
		Install missing junction box cover.
		Install missing junction box hardware.
Miscellaneous		Install missing bolt on guardrail.
3+ years	Deck	Replace approximately 5% of the deck planks.

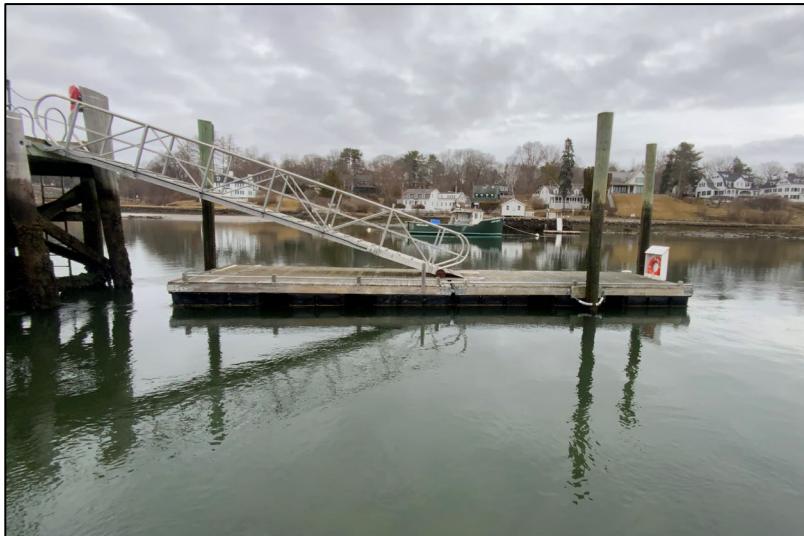
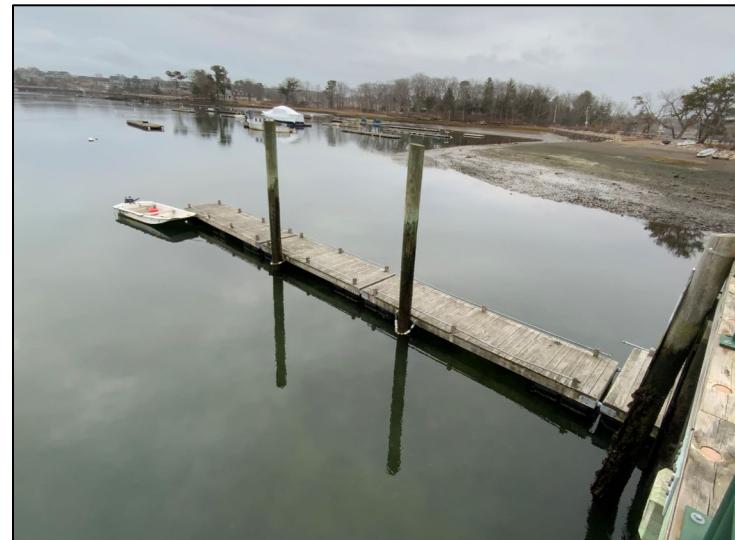
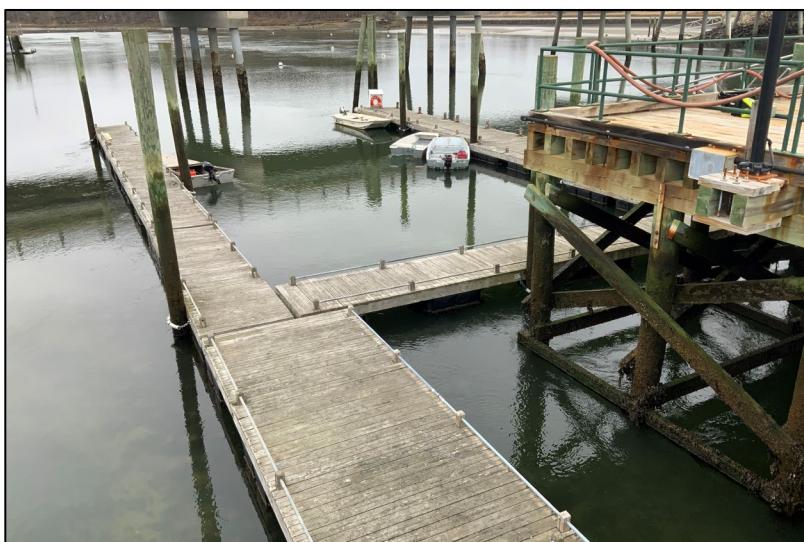
Overall Condition Assessment Rating	Next Recommended Inspection
Poor	2026

Element	Observed Conditions
Float Modules	<p>The float modules generally have moderate corrosion to their connection brackets and severe corrosion to the hardware connecting the plastic floats to the float modules.</p> <p>The pins connecting the float modules generally have minor corrosion and abrasion damage with one, located on the northwest floating dock, that has severe section loss due to abrasion damage. Additionally, one of the cotter pins for the pin connections has been replaced with a screw on the southeast floating dock.</p> <p>The western floating docks have a maximum east-west list of 2 inches and a maximum north-south list of 6 inches. The eastern floating docks have a maximum east-west list of 1.5 inches and a maximum north-south list of 2 inches.</p>
Guide Piles	The timber guide piles have minor to moderate abrasion damage. It also appears that there is a missing guide pile at the end of the southeast floating dock.

Guide Pile Assemblies	There are two guide pile assemblies that are misaligned causing abrasion damage to their associated guide piles. One guide pile assembly is broken.
Deck	The timber decking has moderate weathering and fungal decay.

Element	Observed Conditions
Curbs	The curb is composed of galvanized pipe and timber supports. The timber supports have moderate splitting and fungal decay. Impact damage to the curb was identified at two locations.
Gangways	The western gangway has moderate wheel corrosion and four overstressed deck grates. Additionally, the linchpins for the gangway connection have moderate corrosion. The eastern gangways have minor to moderate corrosion of their linchpins.
Abrasion Plates	The timber abrasion plates, located on the floating dock's deck at the end of each gangway, typically have moderate to severe abrasion damage.
Mooring Hardware	The mooring cleats located along the floating docks are typically loose.

Priority Level	Element	Recommendations
0-3 years	Float Modules	Replace pin connection with severe section loss.
		Replace the screw at the southeast floating dock pin connection with a cotter pin.
	Guide Pile Assemblies	Relocate guide pile assemblies that are causing abrasion damage to the guide piles.
	Gangways	Replace linchpins with moderate corrosion.
		Replace heavily corroded gangway wheels.
		Replace overstressed deck grates.
3+ years	Mooring Hardware	Tighten cleats.
	Floating Dock System	The floating dock system is near the end of its service life and therefore it is recommended that the entire system be replaced.
	Abrasion Plates	Replace timber abrasion plates with Ultra High Molecular Weight Polyethylene (UHMW) plates.

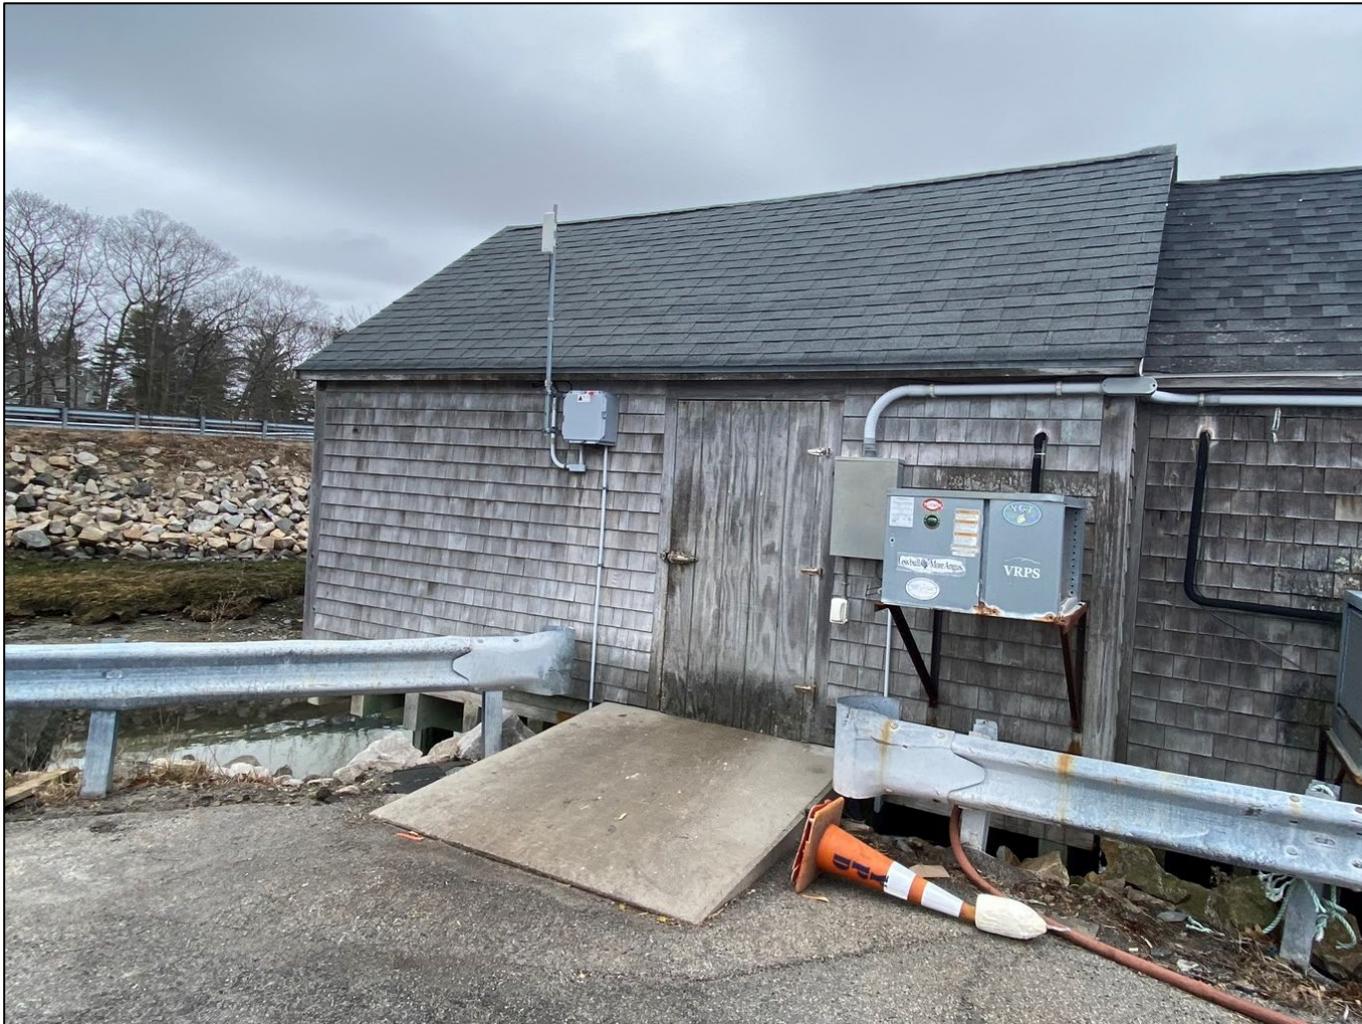
Overall Condition Assessment Rating	Next Recommended Inspection
Satisfactory	2027

Element	Observed Conditions
Piles	The timber piles supporting the town-owned bait shed have no significant defects.
Bracing	The timber diagonal bracing has no significant defects.
Pile Caps	The timber pile caps have no significant defects.
Stringers	The timber stringers have no significant defects.
Deck	The timber deck and the concrete deck overlay have no significant defects.

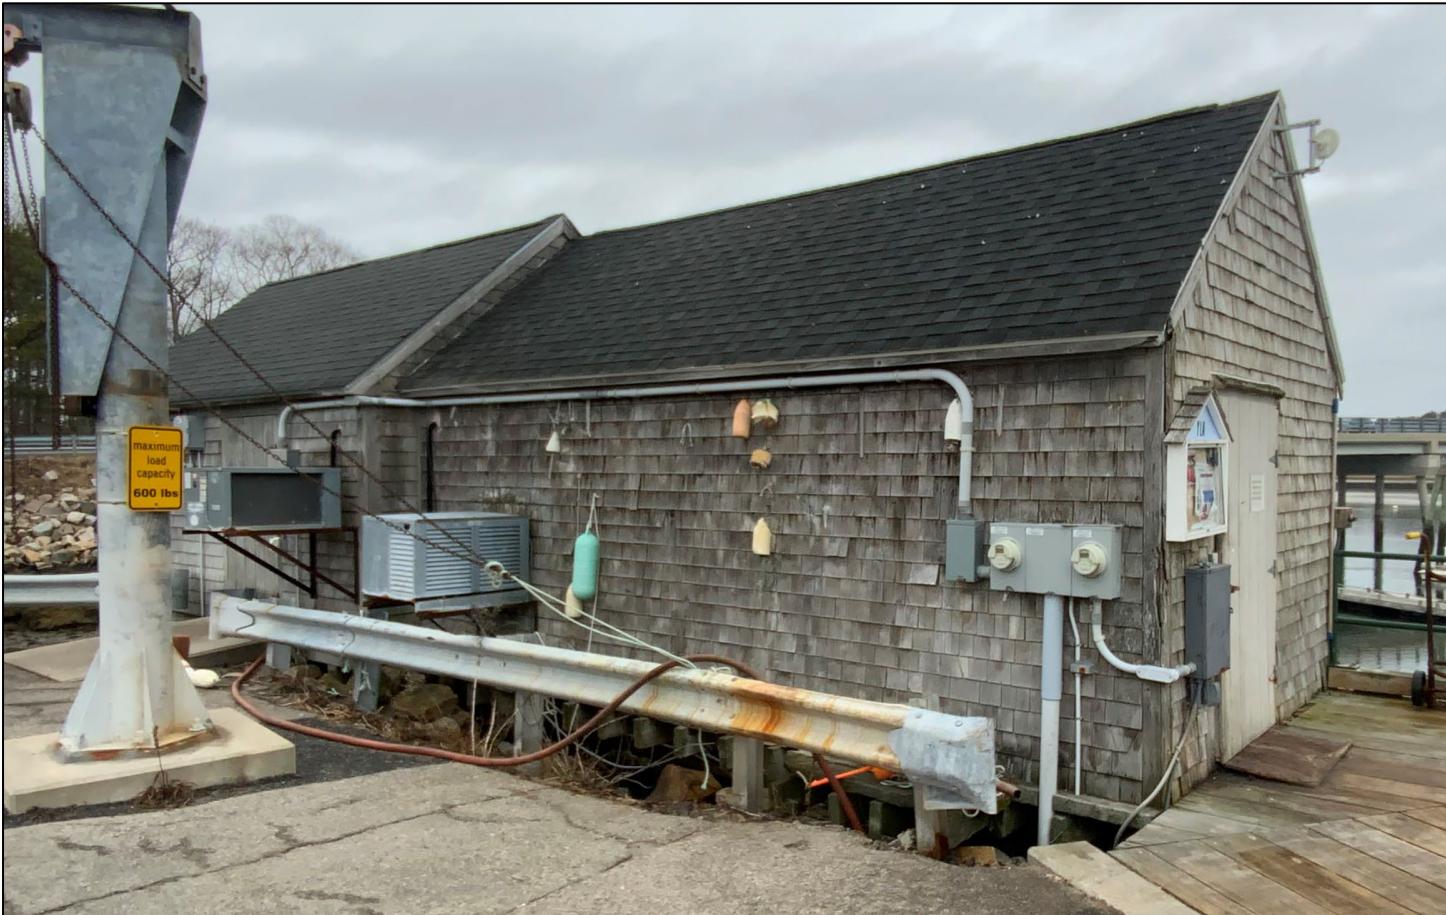
Overall Condition Assessment Rating	Next Recommended Inspection
Poor	2026

Element	Observed Conditions
Piles	The timber piles have major section loss due to marine borer and fungal decay.
Pile Caps	The pile caps have minor weathering.
Stringers	The timber stringers have minor weathering.
Deck	Most of the timber deck is covered by a concrete overlay making it generally inaccessible from the topside. However, the underside portions of the deck have no significant defects, but the perimeter portion of the deck, adjacent to the pavement, has severe fungal decay and section loss.
Deck Overlay	A section of the concrete deck overlay appears to have been intentionally chipped out to promote drainage.
Utilities	The utility hangers located under the facility have severe corrosion.
Building	The building elements have moderate to severe fungal decay. The north-facing portion of the roof is covered in moss and fungus.

Priority Level	Element	Recommendations
0-3 years	General	Due to the deterioration of the piles and building the facility is near the end of its service life and therefore it is recommended that the structure be replaced entirely.

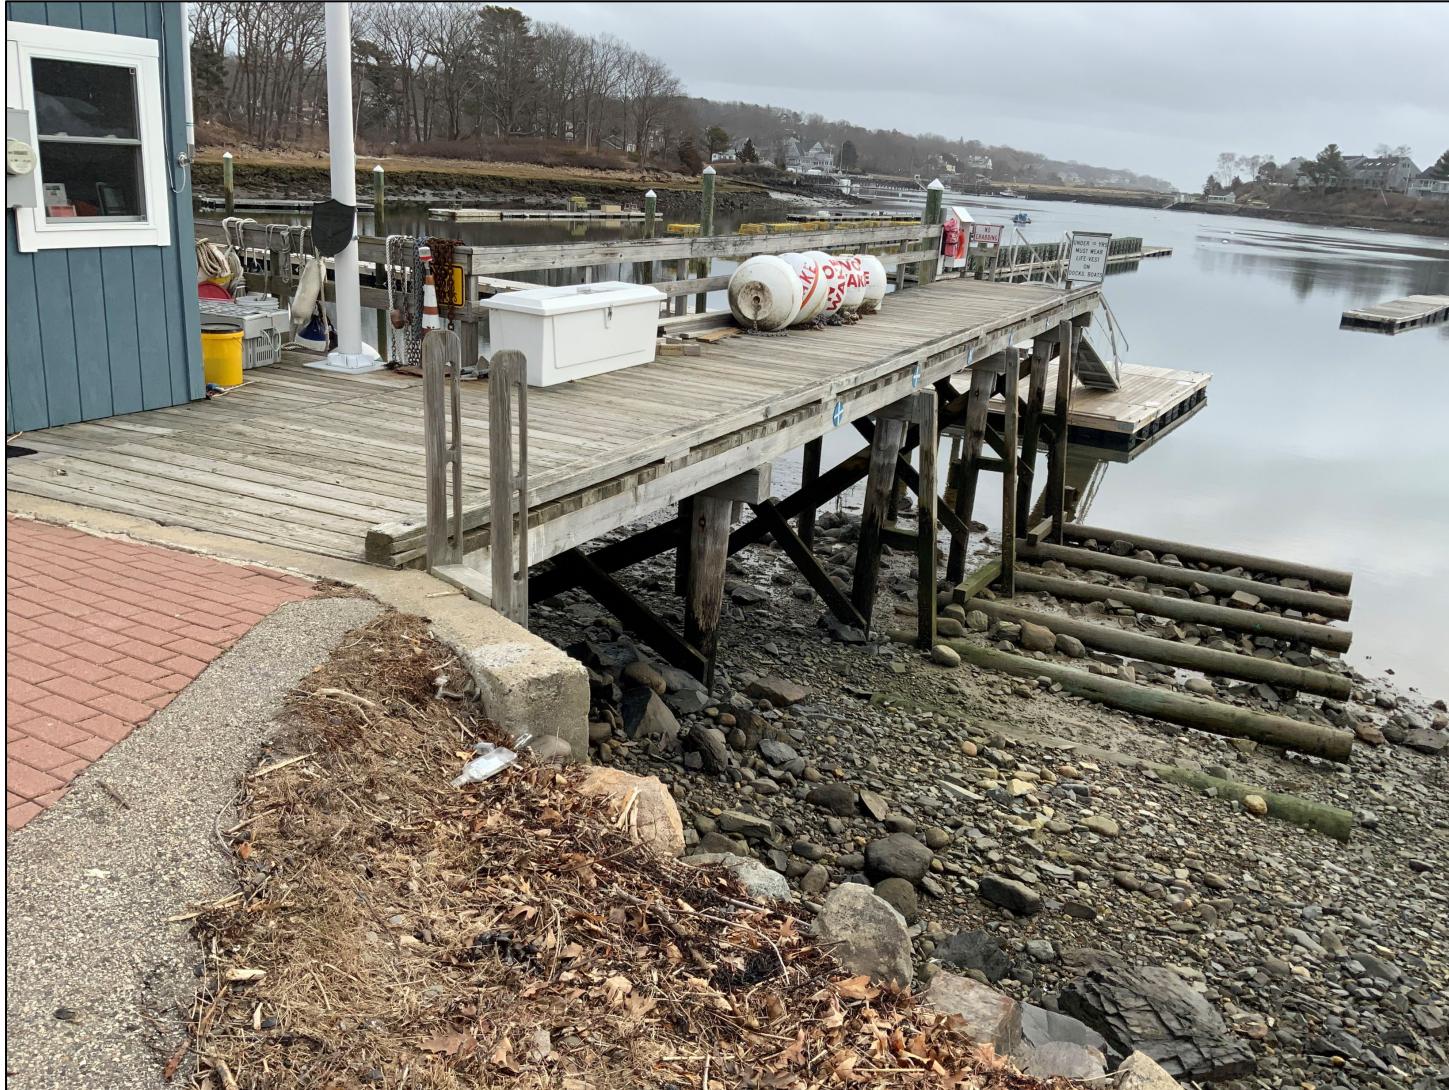
Overall Condition Assessment Rating	Next Recommended Inspection
Poor	2026

Element	Observed Conditions
Piles	The timber piles have major to severe section loss due to marine borer and fungal decay.
Pile Caps	The pile caps have no significant defects.
Stringers	The timber stringers have no significant defects.
Deck	The timber deck has minor weathering.
Curb	The timber curbs have minor weathering.
Utilities	The waterline, which runs the length of the pier, has no significant defects, but the utility hangers to support the waterline are missing.
Miscellaneous	There is no fall protection located on the eastern side of the pier. The guardrail along the western side of the pier has minor weathering.

Priority Level	Element	Recommendations
Immediate	Guardrail	Install guardrail along the eastern side of the pier.
0-3 years	Utilities	Install missing utility hangers.
3+ years	Piles	Replace piles.

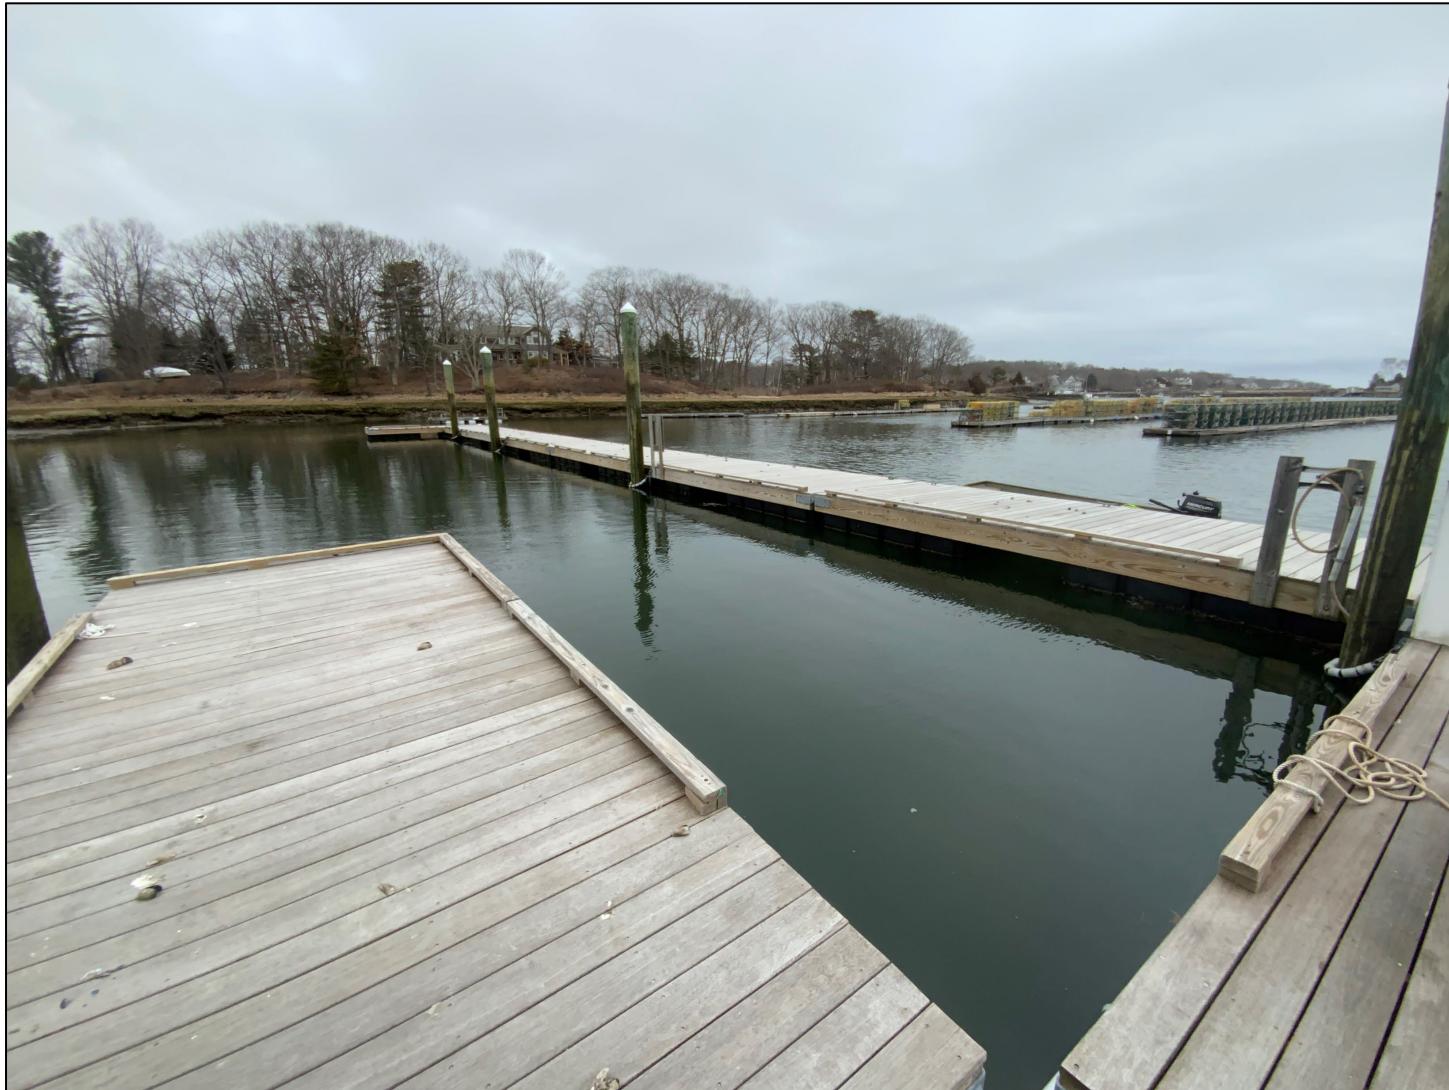
Overall Condition Assessment Rating	Next Recommended Inspection
Satisfactory	2027

Priority Level	Element	Recommendations
0-3 years	Fender System	Reconnect the loose fender element.

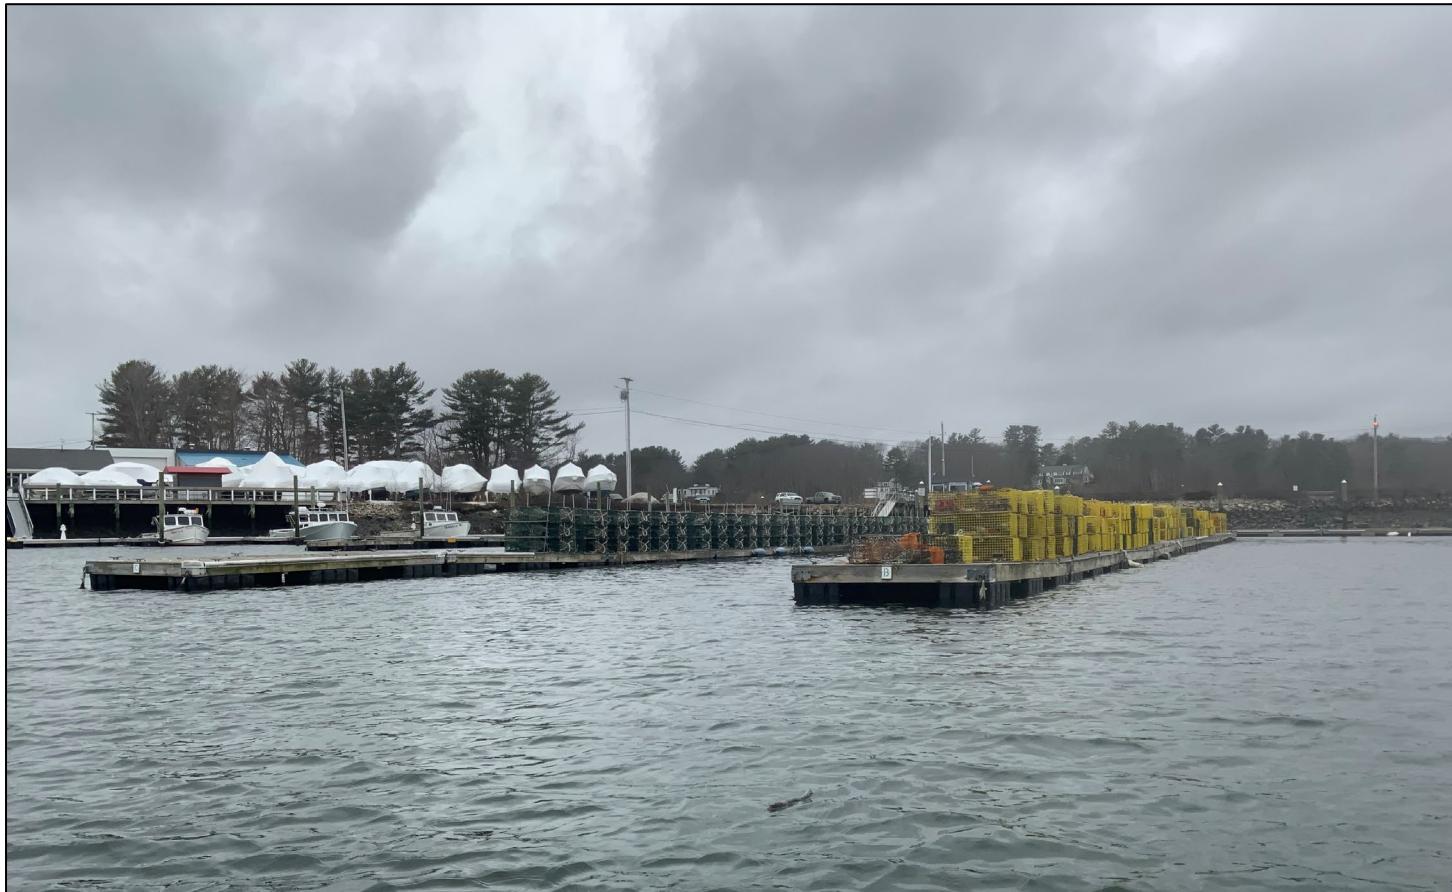
Overall Condition Assessment Rating	Next Recommended Inspection
Fair	2026

Priority Level	Facility	Recommendations
0-3 years	Town Dock 2 – Floating Docks	Reconnect the loose fender element.
	Floating Dock B	Tighten loose pin connection.
		Replace one lynchpin with moderate corrosion.
		Tighten cleats.
3+ years	Floating Dock C	Tighten cleats.
	Town Dock 1 – Main Pier	Replace approximately 5% of the deck planks.
	Town Dock1 – Floating Docks	The floating docks are near the end of their service life and therefore it is recommended that the entire system be replaced.
		Replace timber abrasion plates with UHMW plates.
	Town Dock 2	Replace piles.
	Floating Docks B & C	Due to loss of floatation of the floating docks, it is recommended that the floating docks be replaced.
