Shoreline Survey Reconnaissance Report

Three Priority Sub-Watersheds of the Cape Neddick River

York Community Development Department

March 17, 2011

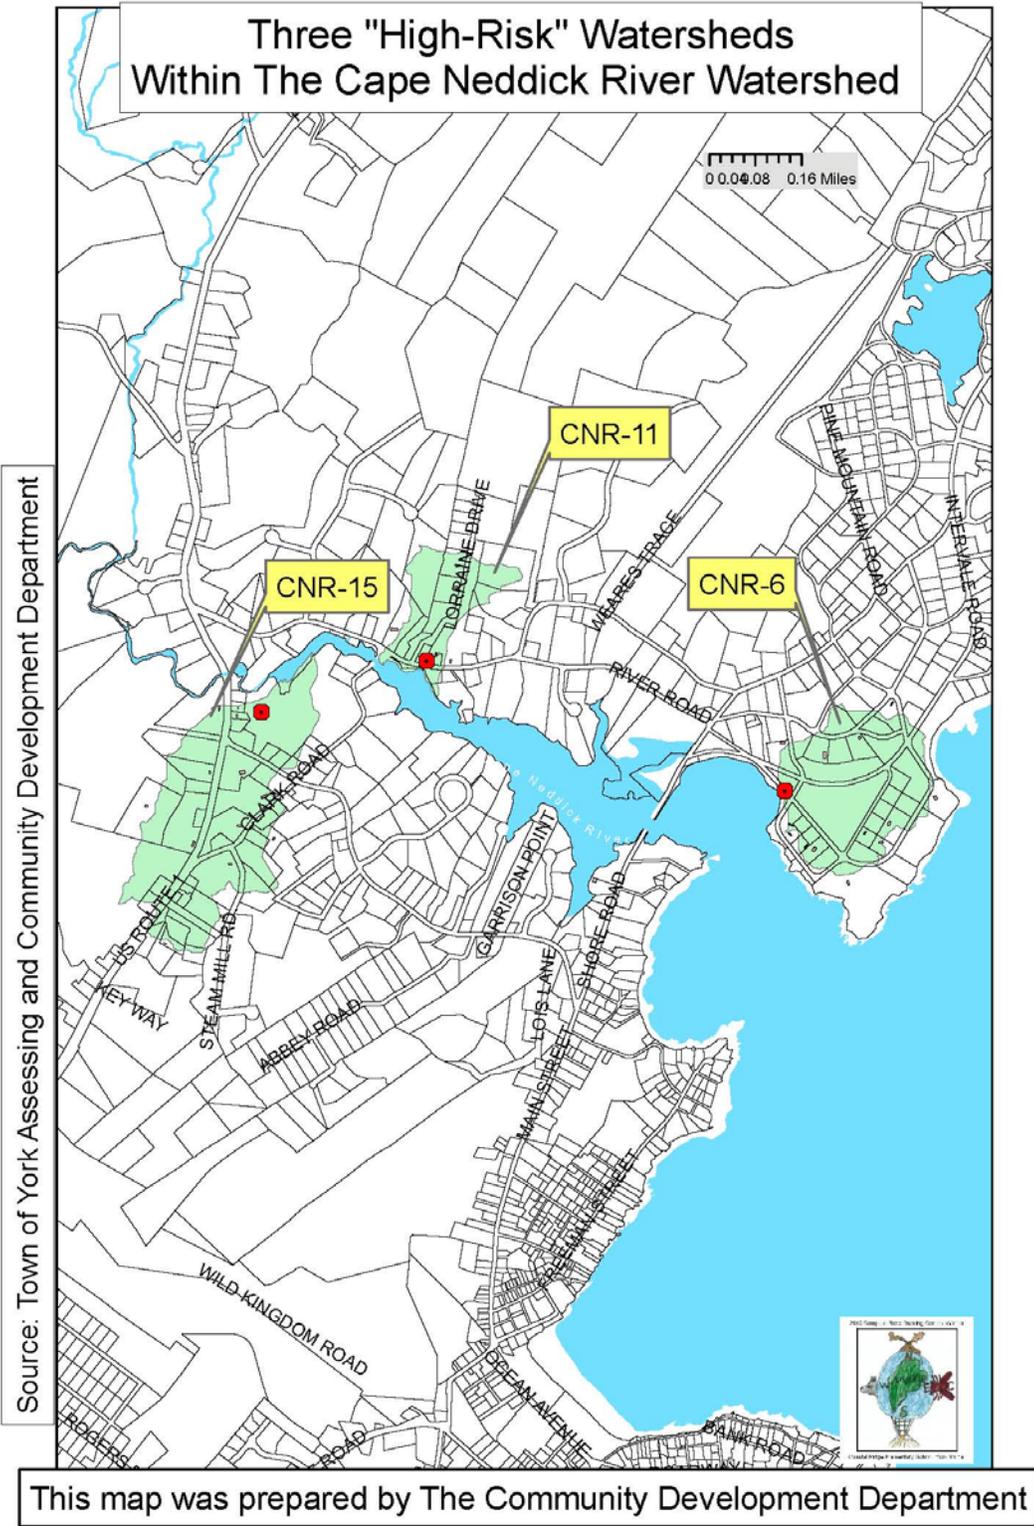
Three "High-Risk" Watersheds Within The Cape Neddick River Watershed

Today we toured 3 sub-watersheds of the lower reaches of the Cape Neddick River. The 3 sub-watersheds visited are upstream from the following water quality testing sites:

- CNR-6 The test site is located adjacent to Cape Neddick Beach at the culvert under Wanaque Road. This is the outfall of a large wetland owned by the Town. Surrounding this wetland are approximately 2 dozen homes.
- CNR-11 This test site is located on the north side of River Road just east of the Clark Road Bridge. A small stream drains a relatively small watershed area with less than a dozen homes.
- CNR-15 This test site is located in the stream which flows to the northeast from the intersection of Route One and Cape Neddick Road. This outfall comes under these two roads and drains a large mixed-use area with about 3 dozen homes and close to a dozen non-residential sites. The exact boundary of this sub-watershed is still being evaluated.

These sub-watersheds were identified by the staff of Maine Healthy Beaches as being the most likely among many tested to be polluted by human sources. This was determined by combined analysis of water quality tests for both bacteria and optical brighteners. Bacteria in the Cape Neddick River has been found to come from human, pet, livestock, wildlife and waterfowl sources. However, optical brighteners, a component in many detergents used to make your whites whiter, are always an indication of human-source pollution. Based on this external prioritization, it was agreed last fall that the Community Development Department would focus resources here first in efforts to clean up the Cape Neddick.
